## **Executive Summary**

## Lake networks in Mahadevpura constituency

## Current lake status in Mahadevpura

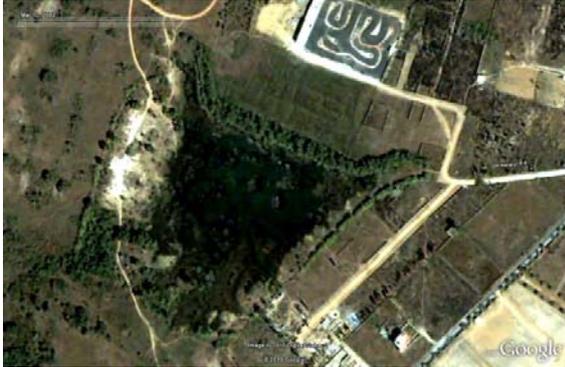
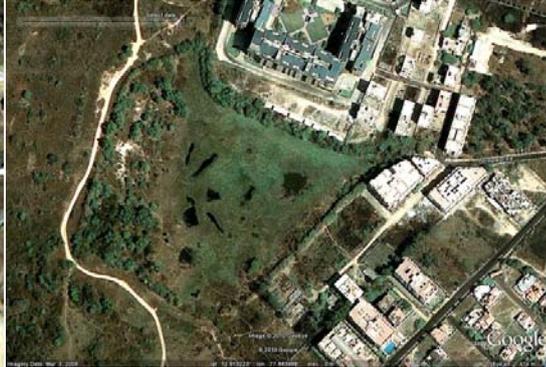
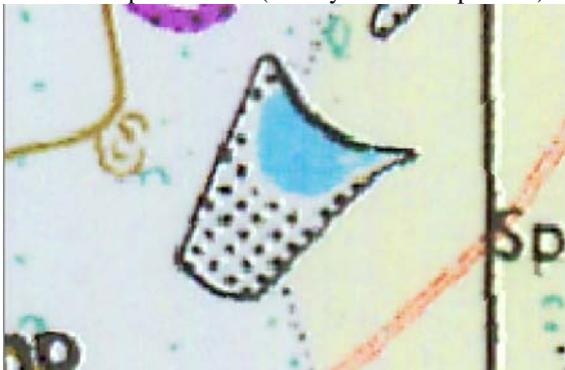
Doddambalipura – 2002 (Google Earth)

Lake/Tank Name	Doddambalipura Kere
Status Of Water body	Completely dry
Detailed Description	Partially fenced, awaiting encroachment clearance and resurvey in military area
Size	5.47 ha
Deep water	1.59 ha
Encroachment	High
Connectivity	Outlet to Ambalipura kere
Flora (Visual Observation)	Bamboo plantation on one side, military area to west has dense tree cover
Fauna (Visual Observation)	Lot of snakes and mongooses
Recommendation	Located in military area. <b>Requires urgent comprehensive desilting,</b> restoration of main bund, and preservation of deep water area to northeast. All inlet and outlet kaluves are completely blocked and encroached, and need to be reclaimed and restored. Partially fenced but needs complete fencing to prevent encroachments. Tree plantation required in north and west. Walking path can be made on north, east and west.

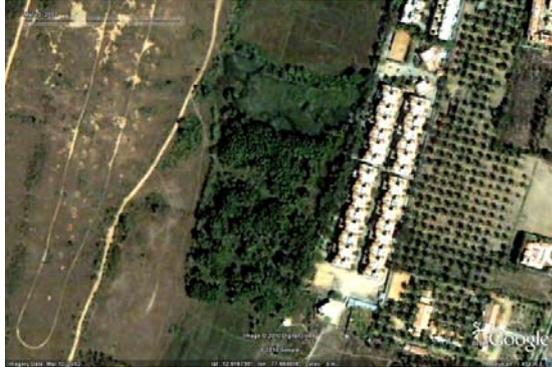
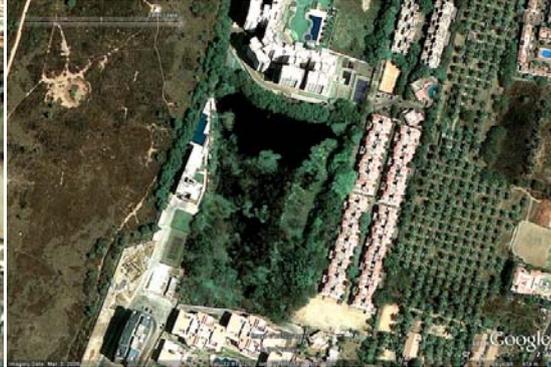
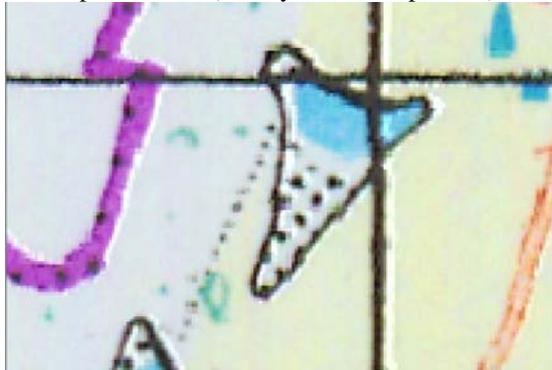
Ambalipura – 2002 (Google Earth)

Lake/Tank Name	Ambalipura Kere (Ambalipura kelagina kere)
Status Of Water body	Restored recently, phase I of restoration completed. Before that, was a polluted, drying up water body, but very rich in biodiversity
Detailed Description	<b>No public access</b> , access only through residential colonies and apartments. Fencing and plans for restoration in progress. High in bird diversity after restoration, but has extensive growth of grass, and some sewage is still entering from nearby layouts. Exit kaluve is encroached.
Size	2.99 ha
Deep water	1.02 ha
Encroachment	Exit kaluve is encroached
Connectivity	Inlet from Doddambalipura; outlet to Ibbalur
Flora (Visual Observation)	Plantation of predominantly Acacia and wild jamun. Several trees dead due to water logging, and have been removed.
Fauna (Visual Observation)	<b>More than thirty species of birds, and very rare observation of Lesser Whistling Ducks, previously not known to breed in Bangalore areas.</b>

Recommendation	Urgently requires prevention of further pollution from sewage. Exit kaluve has been cleared of encroachment, but surrounding areas are still encroached by construction. Phase 1 of restoration is completed, and the lake is very rich in biodiversity. The lake has no public access currently, and this needs to be provided.

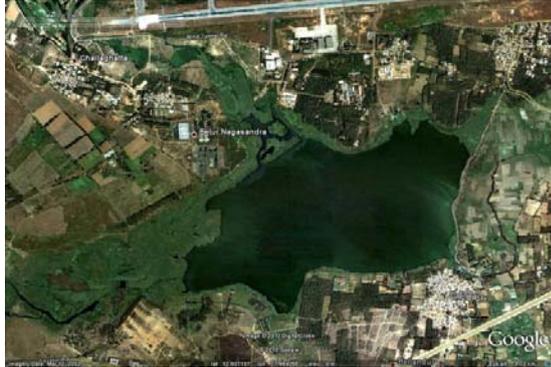
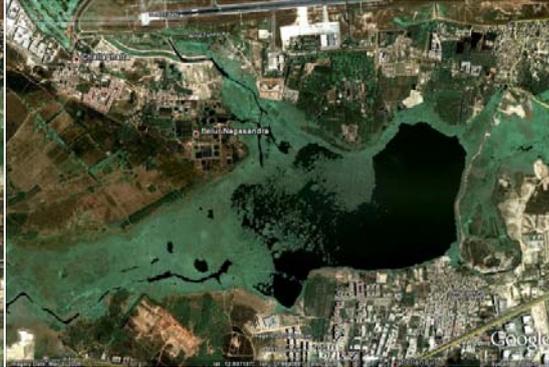
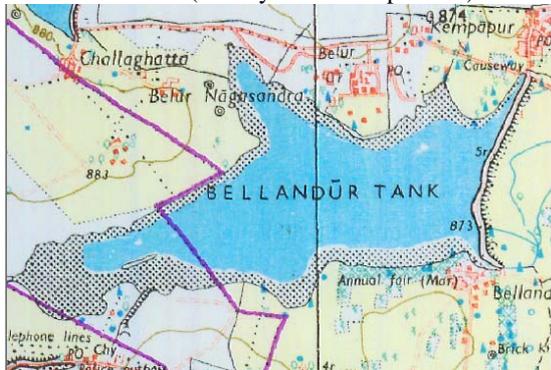
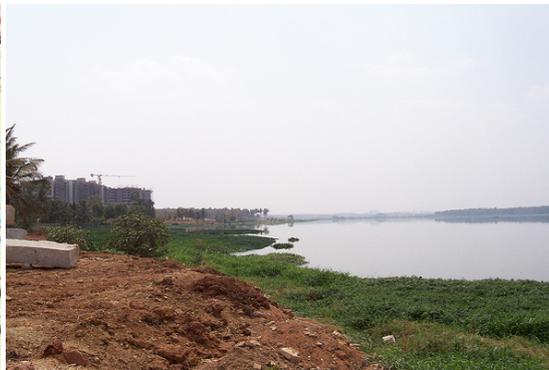
Bellandur – 2002 (Google Earth)

Lake/Tank Name	Bellandur Kere
Status Of Water body	Highly polluted water body
Detailed Description	Extremely polluted with heavy metals, industrial effluents, sewage from residential areas and hospital waste. Heavily encroached and reduced in size, with severe encroachment of rajakaluves including Bellandur canal.
Size	307.35 ha
Deep water	221.11 ha
Encroachment	Lake and kaluves heavily encroached
Connectivity	Inlet from several lakes; outlet to Bellandur canal and to Varthur
Flora (Visual Observation)	Some tree plantations, and significant overgrowth with water hyacinth
Fauna (Visual Observation)	Rich in diversity
Recommendation	The lake urgently requires prevention of further pollution by diverting sewage, industrial waste and hospital waste; biological treatment; <b>creation of multiple STPS</b> as the current STP is under capacity; dredging and restoration of the lake; bund restoration, and <b>removal of encroachments</b> from lake and kaluves in order to provide a healthy supply of rainwater. The toposheet indicates that <b>most of this lake formerly had deep water</b> areas, and this should be kept in mind while restoring the lake. <b>The waterspread area should not be encroached upon for tree plantation</b> as is currently being done. This is one of Bangalore’s largest lakes – maintaining the entire waterspread area is critical for the ground water table in this area. Bicycle and walking trails should be created around the lake.

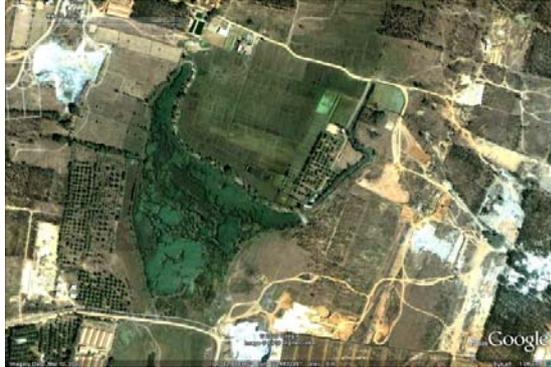
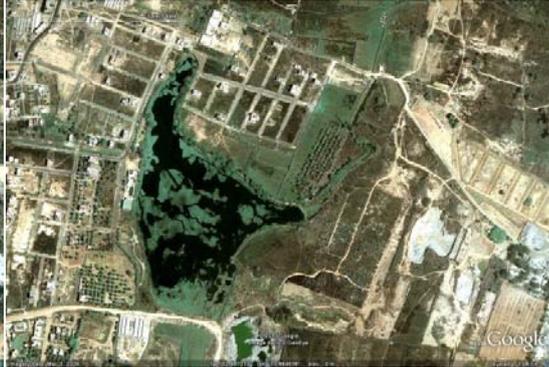
Haralur – 2002 (Google Earth)

Lake/Tank Name	Haralur Kere
Status Of Water body	Healthy water body with some pollution
Detailed Description	Fencing is dilapidated in certain areas around the lake. Dumping at one side of the lake. Used for fishing. Entry to the lake is through a walled residential area (Lakedew Residency).
Size	9.58 ha
Deep water	3.46 ha
Encroachment	Low
Connectivity	Inlet from Kudlu kere; outlet to Kasavanahalli kere
Flora (Visual Observation)	Tree lined tank bund
Fauna (Visual Observation)	Grey heron, Lapwing, Moor hen
Recommendation	Largely healthy water body, does not require extensive dredging and desilting. Urgently requires protection from further encroachment; removal of solid waste and cleaning; prevention of further pollution from sewage by diversion or biological treatment; and restoration of upstream and downstream kaluves to provide a healthy supply of rainwater. Waterspread area should be protected and not encroached for walking path or tree plantation. More trees should be planted around the lake, largely to the north, with a few water tolerant species planted in the southern side. Walking path can be made around the north, east and west sides but the shallow south side with wetlands which is richest in biodiversity, and most sensitive to disturbance, should be protected from human influence. Since this tank is surrounded by villages and urban areas, options should be provided for traditional use such as cattle washing. A small kalyani just before the outlet can be provided for immersion of Ganesha idols, and made available for clothes washing and domestic use at other times of the year.

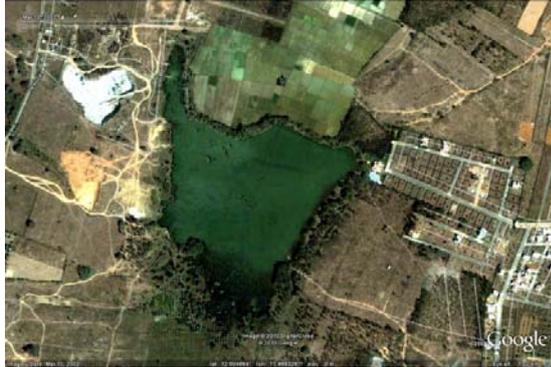
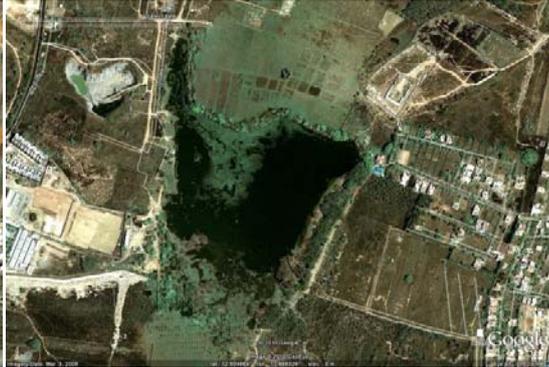
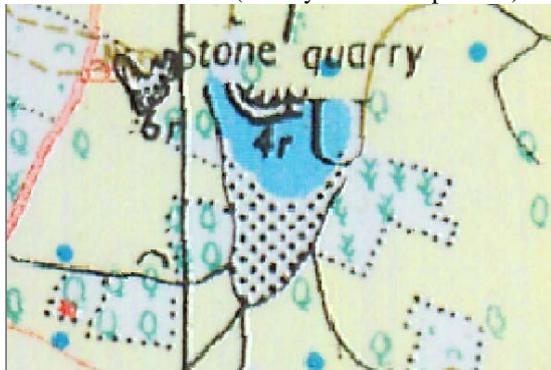
Kasavanahalli – 2002 (Google Earth)

Lake/Tank Name	Kasavanahalli Kere
Status Of Water body	Healthy water body with some pollution
Detailed Description	Part of the tank separated by a bund where sewage is impounded, larger part of the other side of the bund is healthy water body. Lake used for fishing.
Size	15.83 ha
Deep water	4.95 ha
Encroachment	Low
Connectivity	Inlet from Haralur kere; outlet to Kaikondanahalli kere
Flora (Visual Observation)	Acacia Plantation, Arjuna. Several trees in the plantation appear to be dead
Fauna (Visual Observation)	Moor hen, Dabchick, Heron, Egret
Recommendation	Largely healthy water body, but polluted by sewage. Water spread area has shrunk in the north due to encroachment of kaluves and sewage pollution. Large scale desilting and dredging is not required. There should be carefully conducted <b>wet dredging (cutter suction) in selected areas in the north</b> , where it is presently shallow and marshy <b>but should be deep water as per the toposheet</b> . Urgently requires protection from further encroachment; removal of solid waste; biological cleaning and diversion of sewage; and restoration of kaluves. Waterspread area should be protected and not encroached for walking path or tree plantation. Tree cover is adequate on north and west, but needs plantation along the east. No plantation should be done on the shallow south side with wetlands. Walking path can be made around the north, east and west but not on the shallow south side with wetlands which is richest in biodiversity, and most sensitive to disturbance, and should be protected from human disturbance. This tank is surrounded by villages, and traditional use options should be provided for cattle washing. A small kalyani for immersion of Ganesha idols can also be used for clothes washing and domestic use.

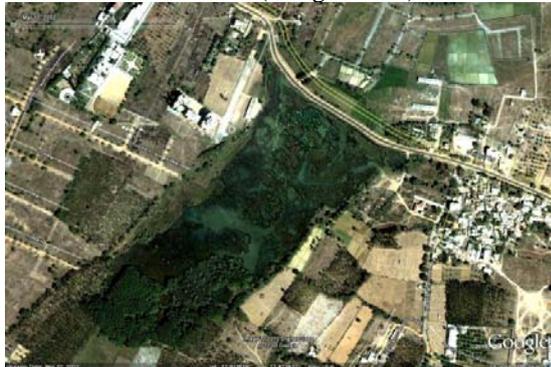
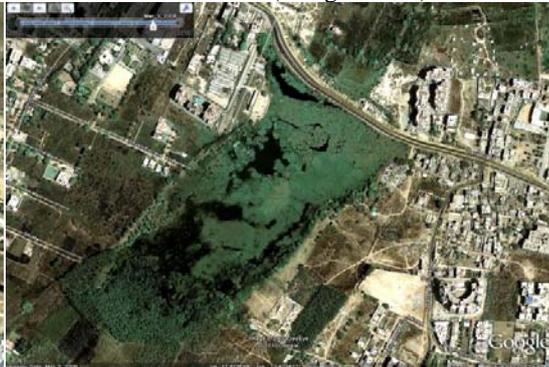
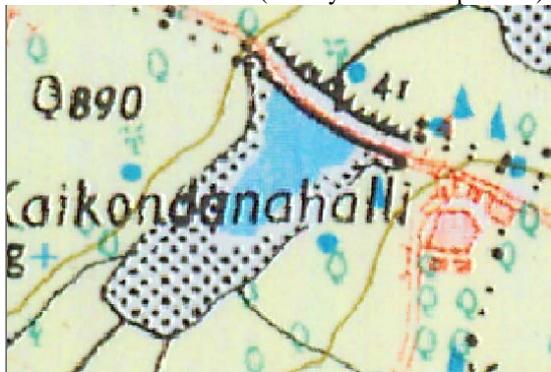
Kaikondanahalli – 2002 (Google Earth)

Lake/Tank Name	Kaikondanahalli Kere
Status Of Water body	Polluted water body
Detailed Description	Fenced, phase 1 of restoration completed. Sewage access has temporarily been blocked. Water is clean, and over 35 bird species have been sighted in recent visits.
Size	18.06 ha
Deep water	5.07 ha
Encroachment	Low
Connectivity	Inlet from Kasavanahalli kere; outlet to Sowle kere
Flora (Visual Observation)	Plantation of predominantly Acacia and Eucalyptus, marsh grass, lantana, Syzygium sp (nerale). New plantation of over 1000 local fruiting and biodiversity friendly trees has just been completed.
Fauna (Visual Observation)	More than thirty species of birds recorded. Also rich in amphibian, insect and snake populations. The central island serves as a resting area for many bird species and other urban wildlife.
Recommendation	Desilting and rejuvenation process completed. <b>No encroachment or acquisition of the northern and western bund for road widening or road construction should be allowed, as is being proposed.</b> Requires prevention of further pollution from sewage; and restoration of upstream and downstream kaluves to provide a healthy supply of rainwater. The lake shows substantial return of bird diversity, as the walking path avoids the shallow south side with wetlands which is richest in biodiversity, and most sensitive to disturbance.

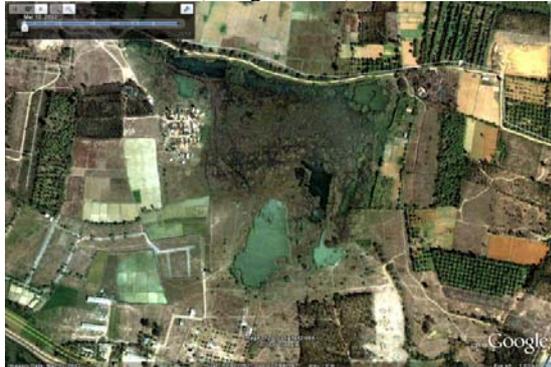
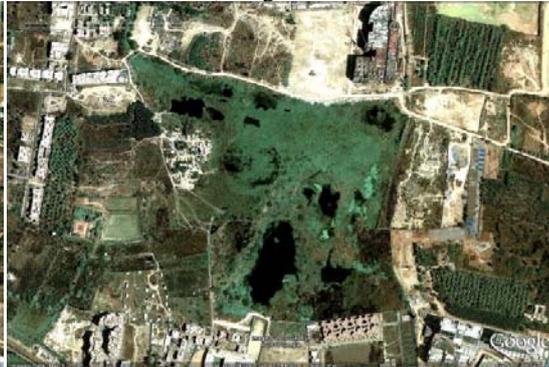
Sowlekere – 2002 (Google Earth)

Lake/Tank Name	Sowle Kere
Status Of Water body	Polluted water body, almost dry due to sewage, encroachment of kaluves, and dumping of construction debris and solid waste
Detailed Description	Completely polluted by sewage flowing into the lake from surrounding colonies. The periphery of the tank has a garbage dump with construction rubble. Lot of construction activity around the lake.
Size	18.33 ha
Deep water	5.25 ha
Encroachment	Seems to be encroached from east and south
Connectivity	Inlet from Kaikondanahalli; outlet to Bellandur canal leading to Varthur
Flora (Visual Observation)	Lantana, grass, Manila tamarind
Fauna (Visual Observation)	Small birds like flower peckers, Robin, sunbirds
Recommendation	<b>Requires urgent prioritisation.</b> This lake needs to be completely fenced, dredged, and restored. Comprehensive desilting <b>should follow the original shape as per SoI toposheet, with deep water to north, and shallow water-marshlands in the south. Encroachments to the east and south should be removed.</b> An STP is required to treat combined sewage from Haralur, Kasavanahalli, Kaikondanahalli and Sowlekere. Inlet and outlet kaluves are completely blocked and encroached, and need to be recovered and restored to provide a healthy supply of rainwater. A row of trees was planted on the northern side, but was cut in 2004. Trees need to be planted around the lake, <b>without encroaching into the waterspread area.</b> Walking path can be made around the north, east and west sides but the shallow south side with wetlands which is richest in biodiversity, and most sensitive to disturbance, should be protected from human influence.

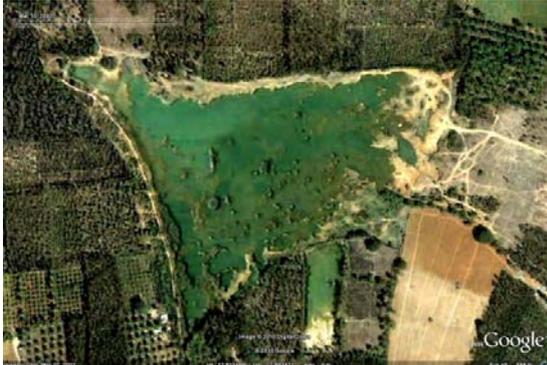
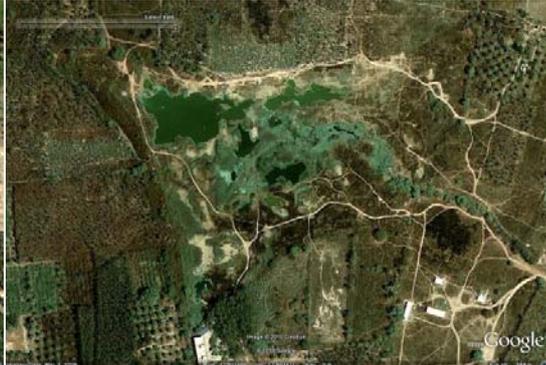
Doddakanalli – 2002 (Google Earth)

Lake/Tank Name	Doddakanalli Kere
Status Of Water body	Almost totally dry, heavily polluted by sewage.
Detailed Description	This lake has been neglected for the past 10 to 15 years. Badly maintained tank bund and encroachment at several points. The lake has no fencing or boundary fixed and there is no approach route to the water body. Almost completely dry.
Size	8.93 ha
Deep water	None
Encroachment	Low
Connectivity	Outlet to Sowlekere
Flora (Visual Observation)	Lantana, Nilgiri plantation, Marsh grass
Fauna (Visual Observation)	Spot billed duck, Egrets, Herons
Recommendation	<b>Requires urgent prioritisation.</b> This lake needs to be completely fenced, dredged, and restored. Inlet and outlet kaluves are completely blocked and encroached, and need to be recovered and restored to provide a healthy supply of rainwater to rejuvenate both Doddakanalli kere and the downstream Sowlekere. Trees need to be planted around the lake, <b>without encroaching into the waterspread area.</b>

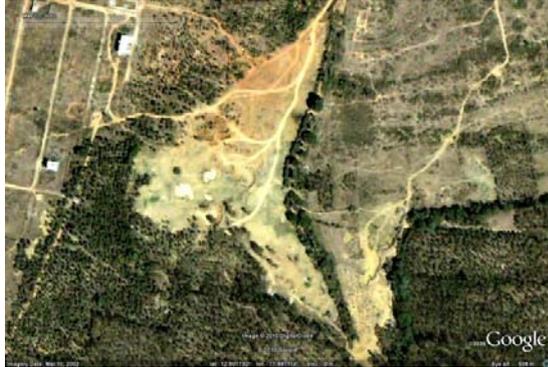
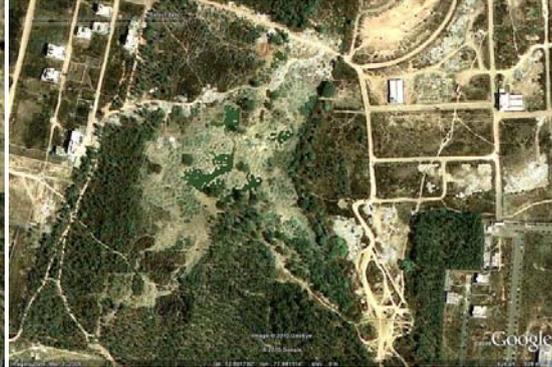
Dommasandra/Junnasandra – 2002 (Google Earth)

Lake/Tank Name	Dommasandra/Junnasandra
Status Of Water body	Almost completely dry
Detailed Description	Marshy, drying, possibly due to encroachment of kaluves. Has a board from tahsildar’s office stating that the lake is government property prominently displayed. Construction debris dumped inside. Has eucalyptus tree growth. Inlet kaluves come from surrounding landscape, which is mostly built up. There is no upstream lake to provide water, but it is a small lake which can be easily well filled by rainwater precipitation. Thus this lake can be maintained as a marshy wetland with water tolerant tree plantations (such as <i>Acacia nilotica</i> ) in the periphery, to act as a biodiversity lake. The lake is surrounded by construction activity, and <b>requires urgent fencing and protection to prevent encroachment.</b>
Size	4.67 ha
Deep water	None
Encroachment	Apparently under dispute on title deed, requires urgent attention

Connectivity	Outlet to Sowlekere
Flora (Visual Observation)	Dominated by eucalyptus plantation
Fauna (Visual Observation)	Common egrets in monsoon
Recommendation	This lake needs to be completely surveyed and fenced <b>urgently</b> . The kaluves connecting the lake need to be dredged, and restored. The trees in this area can be supplemented with additional tree planting, and a continuous walk way can be made around the periphery. This area has substantial potential for <b>plantation of indigenous trees.</b>

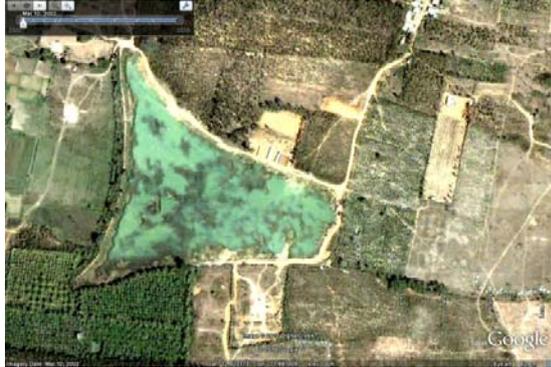
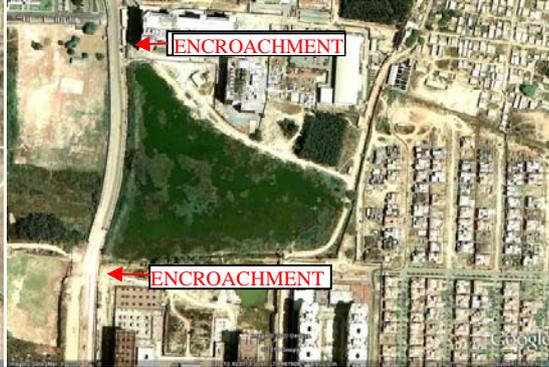
Devarabisanahalli – 2002 (Google Earth)

Lake/Tank Name	Devarabisanahalli Kere
Status Of Water body	Shrinking water body
Detailed Description	Drying lake, due to blocked kaluves; water appears to be fairly clear though with some pollution from sewage. <b>No private access</b> exists, as this lake is surrounded by private property on all sides.
Size	4.64 ha
Deep water	None
Encroachment	Encroached on north and south ends
Connectivity	Inlet from surrounding landscape; outlet to Bellandur canal and Varthur
Recommendation	<b>Requires urgent comprehensive desilting, reclaiming of encroached land,</b> and reclaiming and restoration of inlet and outlet kaluves. Currently completely dry lake, but this is a small lake and can be easily recharged with rain water precipitation if proper dredging is undertaken. <b>Since the lake area is already very small, tree plantation work should be confined to the periphery to avoid further encroachment into water spread area.</b> Plantation must be conducted in the foreshore area to control soil erosion and siltation, along with siltation traps using trenches. A walkway can be constructed around the lake but this should be narrow in width to avoid further shrinkage of waterspread area. Public access must be provided to this lake, in accordance with the status of lakes as public common spaces.

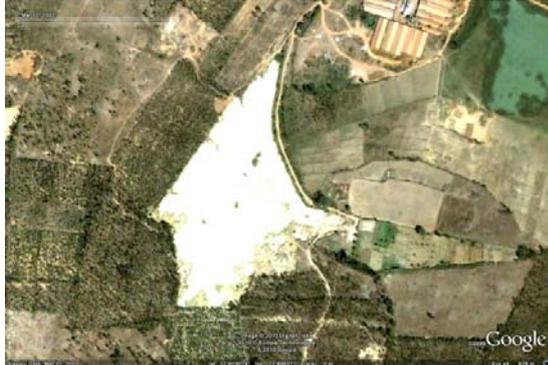
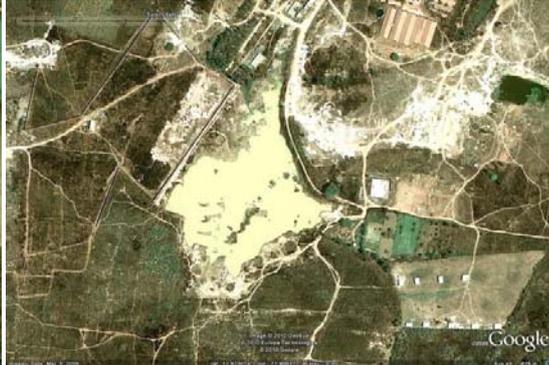
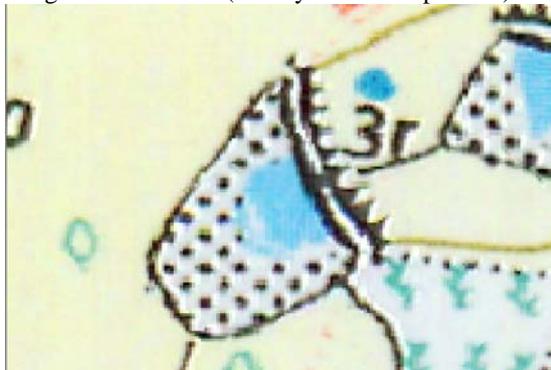
Bhoganahalli – 2002 (Google Earth)

Lake/Tank Name	Bhoganahalli Kere
Status Of Water body	Drying water body, very muddy
Detailed Description	Drying lake,
Size	4.14 ha
Deep water	0.04 ha
Encroachment	Kaluves appear encroached
Connectivity	Inlet from surrounding landscape; outlet to Narasimha Shastri kere
Recommendation	Urgently requires prevention of further pollution from sewage; and restoration of kaluves which have been encroached on by adjoining apartments, in order to provide a healthy supply of rainwater. Requires comprehensive desilting and rejuvenation, keeping the original structure of the lake intact with deep water to the east. The lake is already small and the waterspread area should not be used to make a wide walking path or for extensive tree plantation – instead a single row of large indigenous trees can be planted around, with a narrow walkway. The foreshore area should be planted with trees to control soil erosion and siltation, along with silt traps in the form of trenches. As this is a small lake there is potential for complete filling due to rainwater precipitation, but the kaluves need to be reclaimed and restored.

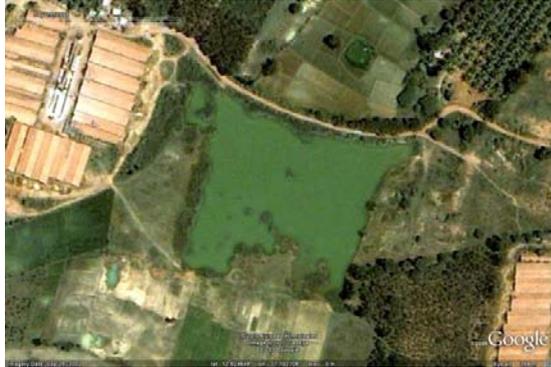
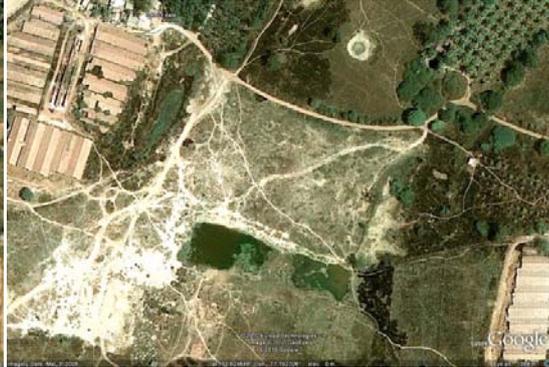
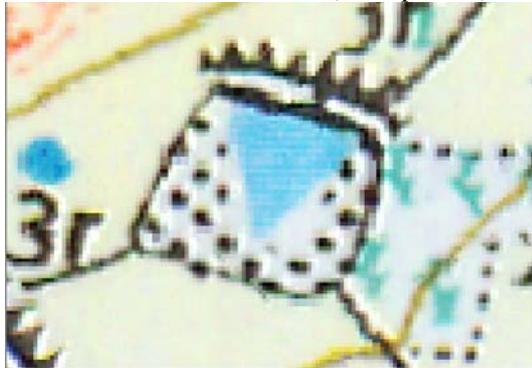
Narasimha Shastri kere – 2002 (Google Earth)

Lake/Tank Name	Narasimha Shastri Kere
Status Of Water body	Completely dry, <b>totally encroached and fenced as private property</b>
Detailed Description	Formerly connected to Bhoganahalli, now completely dry. The lake has been allotted to a private owner who has fenced the lake - <b>private allotment needs to be revoked and the lake reclaimed</b> . Inlet kaluves are blocked, and the lake bed is completely dry.
Size	2.02 ha
Deep water	0.04 ha
Encroachment	Kaluves appear encroached; <b>entire lake is encroached</b>
Connectivity	Inlet from Bhoganahalli; outlet to Panathur – I
Recommendation	Requires comprehensive desilting and rejuvenation, keeping the original structure of the lake intact with deep water in the north. The lake needs to be retrieved from private property developers. Connection to the adjacent Bhoganahalli lake should be restored on priority basis. The lake is already small and the waterspread area should not be used to make a wide walking path or for extensive tree plantation – instead a single row of large indigenous trees can be planted around, with a narrow walkway. As this is a small lake there is potential for complete filling due to rainwater precipitation, but the kaluves need to be reclaimed and restored.

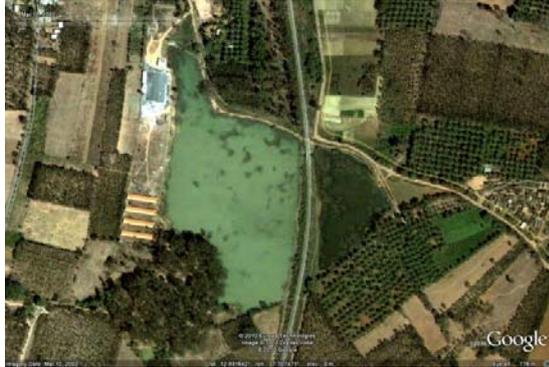
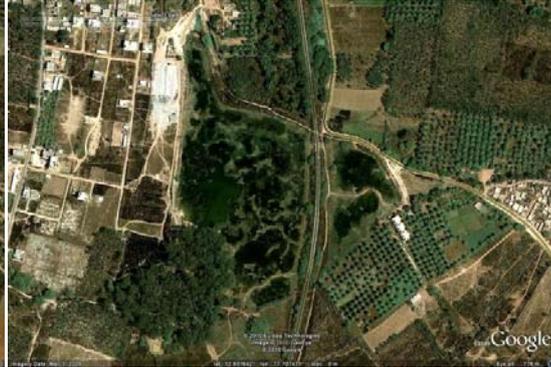
Panathur 1 – 2002 (Google Earth)

Lake/Tank Name	Panathur Kere - 1
Status Of Water body	Polluted, drying up water body, but rich in biodiversity
Detailed Description	Covered with marshy grass and encroached by weeds, very polluted with sewage.
Size	8.45 ha
Deep water	7.8 ha
Encroachment	Kaluves encroached
Connectivity	Inlet from Bhoganahalli and Narasimha Shastri kere; outlet to Bellandur canal and then to Varthur
Flora (Visual Observation)	Marshy grass, lantana, Eucalyptus
Fauna (Visual Observation)	Good bird and insect diversity
Recommendation	As per Survey of India toposheet details, this lake is a deep water lake, with two other lakes draining into it – although not very large in size, it therefore has good potential for water storage. Comprehensive desiltation and dredging is required to create a <b>deep water spread area</b> . The lake requires urgent <b>prevention of sewage pollution through bioremediation and diversion of sewage</b> . <b>Restoration of encroached kaluves</b> is also essential for this deep water lake in order to provide a healthy supply of rainwater. There is good potential for <b>plantation of local trees around the lake</b> . A tree lined walking path can also be created, but the area adjacent to the tree plantation on the southwest should be left undisturbed, without access, so that bird life is not disturbed. Care should be taken not to create very wide walking paths which will encroach on and restrict the waterspread area.

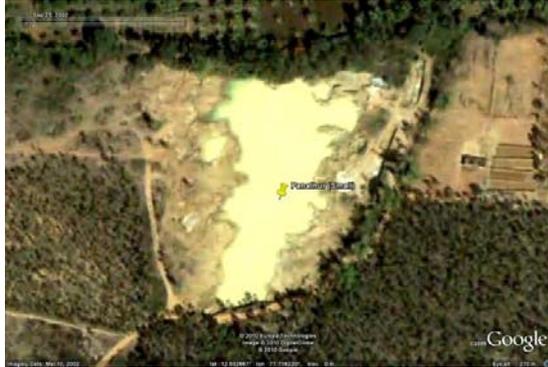
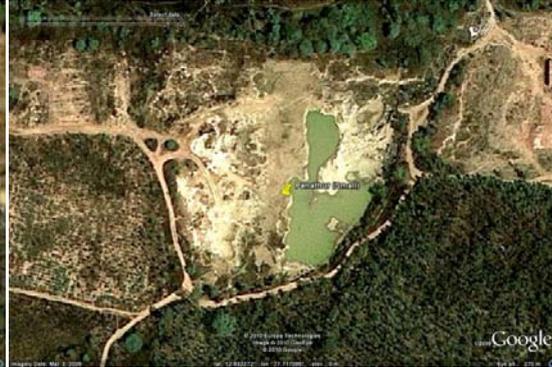
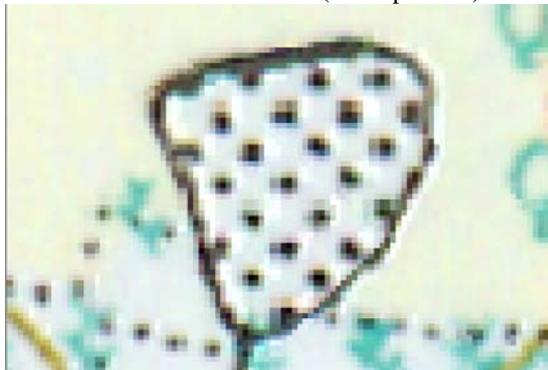
Panathur 2/Hosur kere – 2002 (Google Earth)

Lake/Tank Name	Panathur Kere 2/Hosur kere
Status Of Water body	Almost completely dry
Detailed Description	Very dry lake, with blocked kaluves.
Size	1.68 ha
Deep water	None
Encroachment	Kaluves appear encroached
Connectivity	Inlet from surrounding landscape; outlet to Varthur lake
Flora (Visual Observation)	Surrounded by extensive tree plantations
Fauna (Visual Observation)	Rich in bird and insect life
Recommendation	Urgently requires comprehensive desilting and restoration program; prevention of further pollution from sewage through bioremediation and diversion; and reclamation and restoration of kaluves, in order to provide a healthy supply of rainwater. This is a small lake and can easily be filled by precipitation if the kaluves are opened. As this lake is very rich in biodiversity, and small in size, a small walking path can be provided but this should not be very wide and restrict the already limited waterspread area. The walking path should not be circular, and should avoid the eastern edge near the plantations as an undisturbed area for bird and insect life.

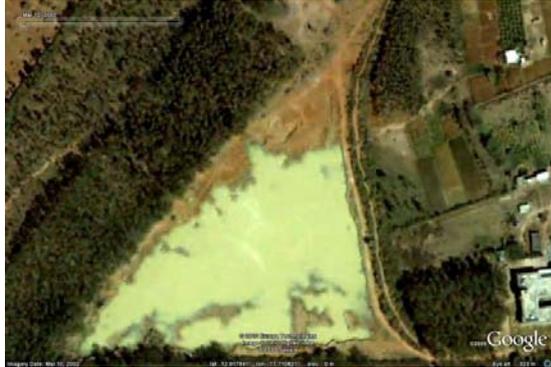
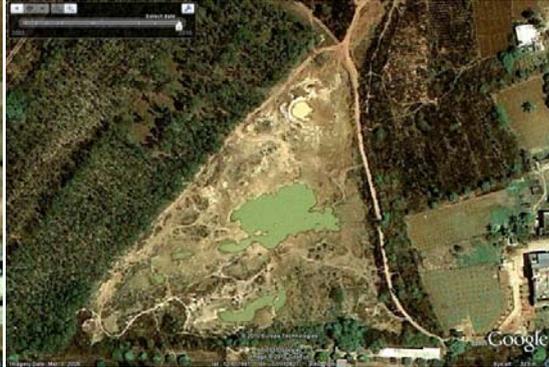
Gunjur kere Carmelaram – 2002 (Google Earth)

Lake/Tank Name	Gunjur kere Carmelaram
Status Of Water body	Almost completely dry
Detailed Description	Fencing in progress. Complete encroachment of kaluves, and lake is located within private boundary.
Size	2.6 ha
Deep water	None
Encroachment	Kaluves encroached
Connectivity	Inlet from surrounding landscape; outlet to Gunjur palya kere
Flora (Visual Observation)	Surrounded by tree plantations
Fauna (Visual Observation)	Rich in bird and insect life, very high diversity of butterflies
Recommendation	Urgently requires comprehensive desilting and restoration program; and reclamation and restoration of kaluves, in order to provide a healthy supply of rainwater. This is a small lake and can easily be filled by precipitation if the kaluves are opened. Appropriate water tolerant trees can be planted on the east, north and south. As this lake is very rich in biodiversity, and small in size, a small walking path can be provided but this should not be very wide and restrict the already limited waterspread area. The walking path should not be circular, and should avoid the western swampy edge leaving it as an undisturbed area for bird and insect life.

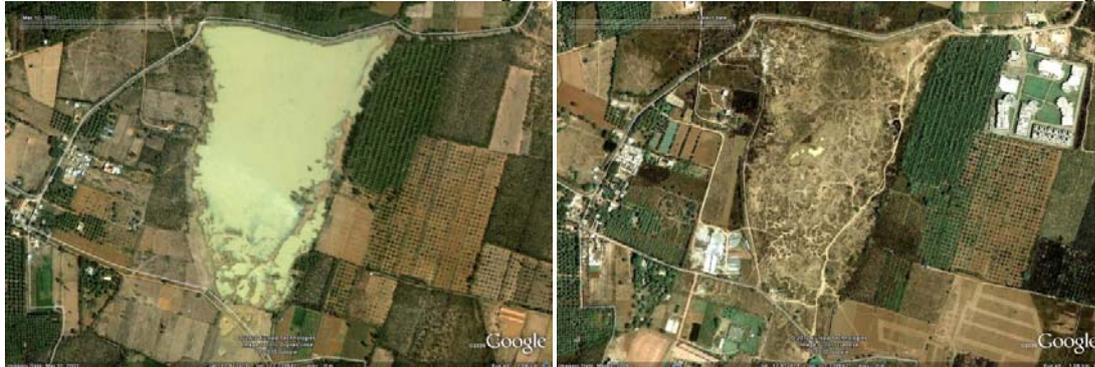
Chikkabellandur/Gowrammana kere 2002 (Google E) Chikkabellandur/Gowrammana kere – 2009 (Google E)

Lake/Tank Name	Chikkabellandur kere/Gowrammana kere
Status Of Water body	Dry lake
Detailed Description	Almost completely dry lake bed, with blocked kaluves.
Size	22.11 ha
Deep water	14.23
Encroachment	Kaluves completely encroached
Connectivity	Inlet from surrounding landscape; outlet to Gunjur palya kere
Flora (Visual Observation)	Very few trees, some short grass, largely open soil
Fauna (Visual Observation)	Snakes, mongoose, other rodents
Recommendation	Urgently requires comprehensive desilting and restoration program; and reclamation and restoration of kaluves, in order to provide a healthy supply of rainwater. This is a small lake and can easily be filled by precipitation if the kaluves are opened. The lake has significant potential for rain water harvesting as <b>about 60% of the lake is deep water area</b> . This should be retained during the rejuvenation program. Appropriate shade giving trees should be planted on all sides, with foreshore planting of trees to reduce siltation. A narrow walking path is required around part of the lake, taking care to avoid the shallow area and leave it as a refuge for biodiversity.

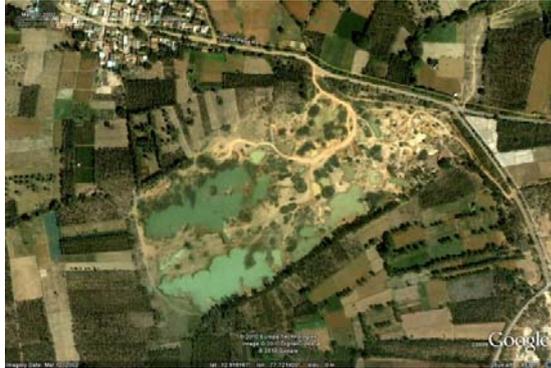
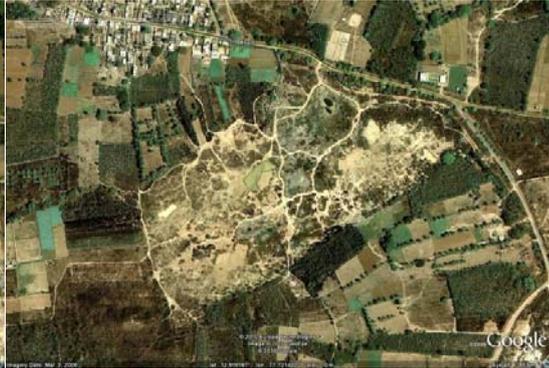
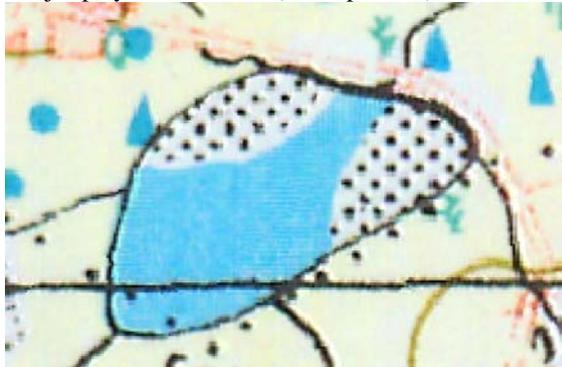
Lake/Tank Name	Gunjur palya kere
Status Of Water body	Completely dry
Detailed Description	Dry lake bed, all kaluves blocked, overgrown with weeds, encroached to the north-west.
Size	13.75 ha
Deep water	9.99
Encroachment	Kaluves encroached, encroachment on north-west of lake
Connectivity	Inlet from Gunjur kere Carmelaram, and Chikkabellandur kere; outlet to Varthur lake
Flora (Visual Observation)	Weeds and shrubs on dry lake bed
Fauna (Visual Observation)	Snakes, mongoose, small mammals, some birds and insects
Recommendation	Urgently requires comprehensive desilting and restoration program; prevention of pollution from sewage through bioremediation and diversion; and reclamation and restoration of kaluves, in order to provide a healthy supply of rainwater. This lake will hold a substantial amount of water as most of the lake is deep water, and this should be kept in mind during restoration. Since the lake has inlets from two other lakes, it can easily be filled by precipitation if the kaluves are cleared and opened. There is abundant scope for plantation of a large number of shade providing trees all around the edge, and trees should be planted in the foreshore area to control soil erosion and siltation. A walking path should be provided as this lake has good public access through the Gunjur palya road, and has substantial scope for use for recreation. The walking path should be narrow and should not restrict the waterspread area. The walking path should avoid the south-western edge that is away from the roads, to create an undisturbed area for bird and insect life.

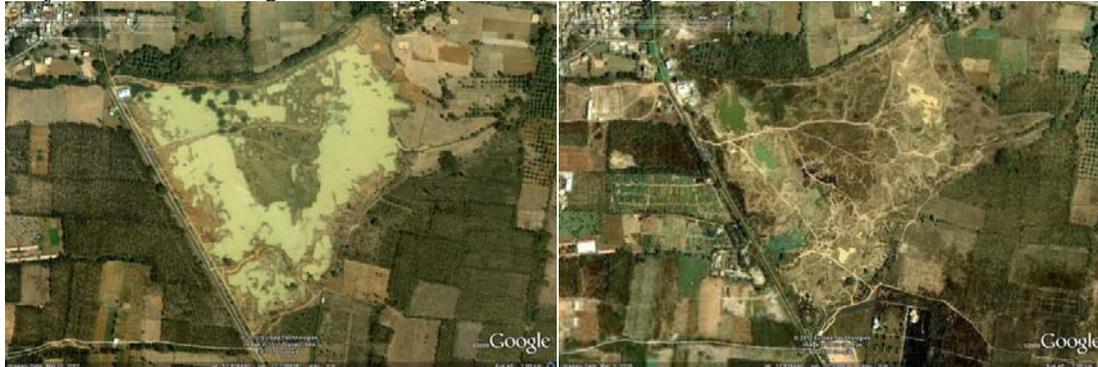
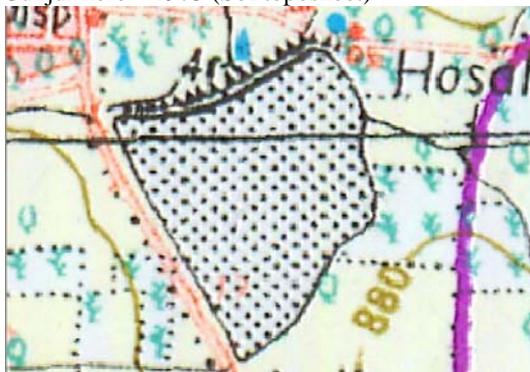
Lake/Tank Name	Gunjur kere
Status Of Water body	Almost completely dry
Detailed Description	Dry lake, kaluves are completely blocked.
Size	22.39 ha
Deep water	None
Encroachment	Kaluves appear encroached
Connectivity	Inlet from surrounding landscape; outlet to Varthur lake
Flora (Visual Observation)	Grass, shrubs and weeds, with few trees around periphery
Fauna (Visual Observation)	Rich in bird and insect life
Recommendation	Urgently requires comprehensive desilting and restoration program; prevention of further pollution from sewage through bioremediation and diversion; and reclamation and restoration of kaluves, in order to provide a healthy supply of rainwater. This is a large lake and it is important to prioritize its restoration to recharge ground water levels in the region. The natural water slope should be maintained, with deeper water near the northern bund area and shallow water in the south. Tree planting is required in the foreshore to control soil erosion and siltation. The lake is rich in biodiversity, and a tree lined walking path can be provided around the lake for recreation. But should be narrow so as to restrict the waterspread area. The walking path should not be circular, and should avoid the south-western shallow water edge away from the road, leaving this as an undisturbed area for bird and insect life.

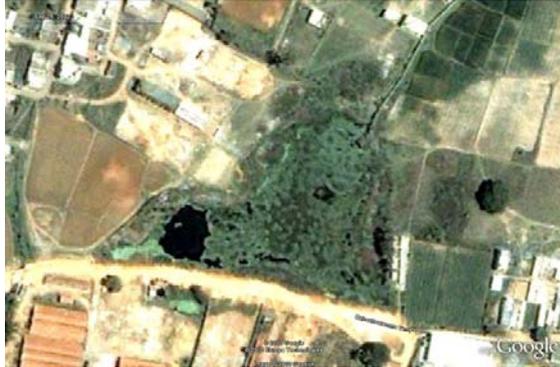
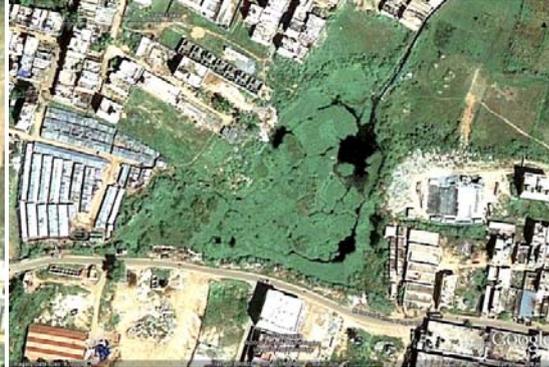
Lake/Tank Name	Garudachar palya kere 1
Status Of Water body	Almost completely dry
Detailed Description	Encroachment of kaluves, heavily polluted by sewage, dumping of construction debris and solid waste
Size	1.39
Deep water	None
Encroachment	Kaluves encroached, lake appears to have been encroached before 2002 on the southeastern edge (based on the Survey of India toposheet)
Connectivity	Inlet from surrounding landscape; outlet to Mahadevpura kere
Flora (Visual Observation)	Marshy grass and weeds
Fauna (Visual Observation)	Birds and insects
Recommendation	Urgently requires comprehensive desilting and restoration program; and reclamation and restoration of kaluves, in order to provide a healthy supply of rainwater. The shape should be checked against the village survey maps to confirm if there is encroachment on the southeastern corner. This is a small lake and can easily be filled by precipitation if the kaluves are opened. There is no tree cover, and appropriate shade giving and biodiversity friendly trees should be planted around the lake. As this lake is small in size, a walking path can be provided but this should not be very wide and restrict the already limited waterspread area. The walking path should not be circular, and should avoid the northern edge which is away from the road, leaving it as an undisturbed area for bird and insect life.

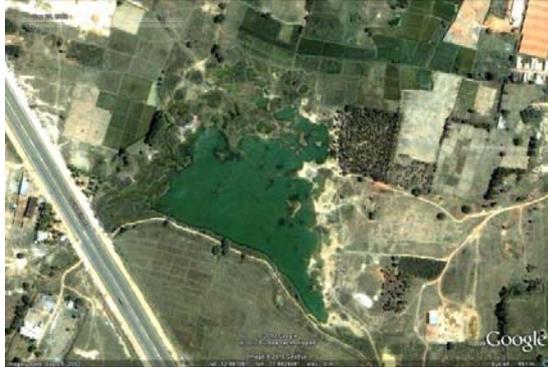
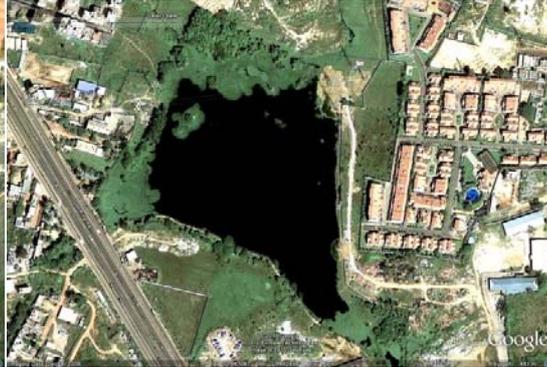
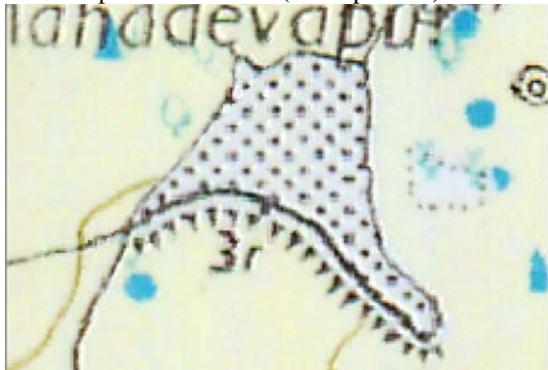
Lake/Tank Name	Mahadevpura kere
Status Of Water body	Reasonably healthy water body with some pollution from sewage
Detailed Description	Southwest and northern boundaries polluted with sewage and encroached by water hyacinth. The rest of the lake appears to be in reasonably good condition. The lake has been fenced. Coracle fishing was observed.
Size	8.29 ha
Deep water	None
Encroachment	Kaluves encroached
Connectivity	Inlet from Garudachar palya kere 1; outlet to Dodda Nekkundi kere
Flora (visual observation)	Bamboo, mango, other large trees along western boundary
Fauna (visual observation)	Good bird and insect diversity, observed fishing in the lake
Recommendation	Requires diversion of sewage entry, and biological treatment of water. Cutter suction can be conducted to treat the areas of siltation to the north and west. Reclamation and restoration of kaluve connecting Garudachar palya kere 1 is required, in order to maintain a healthy supply of water. The lake has good tree cover, which can be supplemented by providing some trees around the the lake. Appropriate water tolerant trees should be planted in the swampy areas to the north, with a walking path that goes around the boundary, but which avoids the northern swampy areas leaving this as an undisturbed refuge for biodiversity.

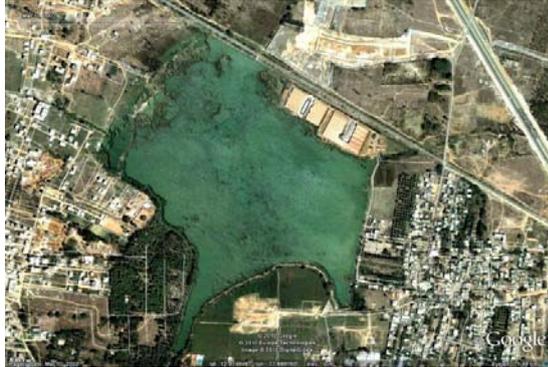
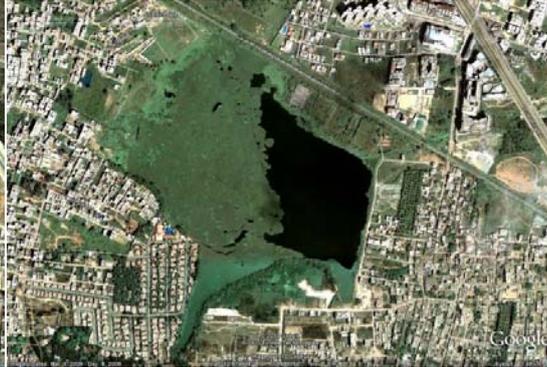
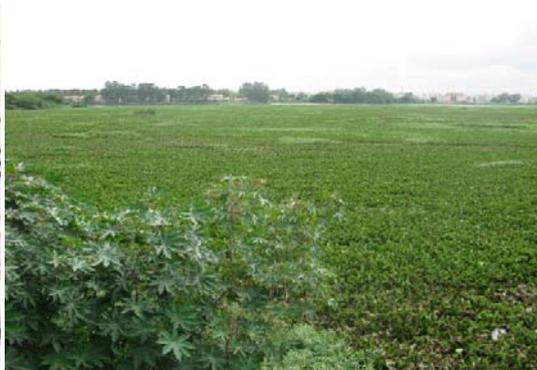
Lake/Tank Name	Dodda Nekkundi kere
Status Of Water body	Heavily polluted water body
Detailed Description	Heavily polluted by sewage, with the western 2/3rds almost completely encroached by water hyacinth. Complete encroachment of kaluves.
Size	45.29 ha
Deep water	11.53
Encroachment	Kaluves encroached; lake appears encroached compared to the Survey of India toposheet
Connectivity	Inlet from multiple lakes including Mahadevpura kere; outlet to Vartur kere
Flora (visual observation)	Few trees along southern boundary, some bamboo at the western end.
Fauna (visual observation)	Some birds, but low diversity because of extreme coverage by water hyacinth
Recommendation	Urgently requires comprehensive desilting and restoration program; and reclamation and restoration of kaluves, in order to provide a healthy supply of rainwater. Care should be taken to follow the original pattern of sorage, with deep water areas to the south. This lake can hold a great deal of water as it is large, has about 25% area for deep water storage, and has multiple lakes feeding into it. Kaluves need to be cleared, and incoming water treated through bioremediation or an STP; further inflow of sewage should be diverted as well. There is substantial scope for plantation of a large number of shade providing, biodiversity friendly trees. Appropriate water tolerant trees can be planted on the east, north and south. A walking and bicycle path should be provided around part of the lake, avoiding the marshy areas and leaving them undisturbed as a refuge for wildlife and birds.

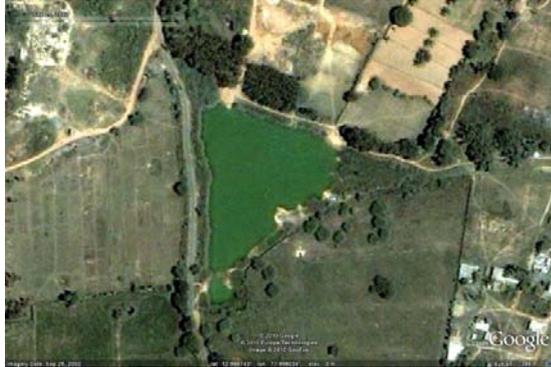
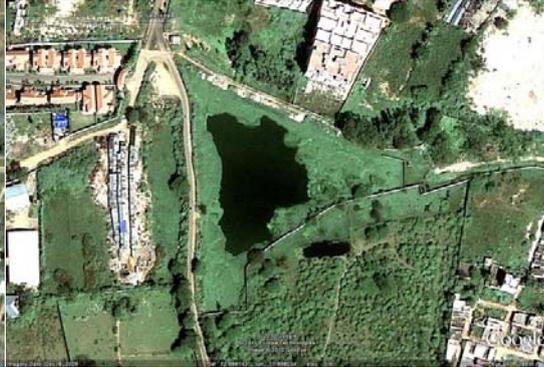
Lake/Tank Name	Garudachar palya kere 2
Status Of Water body	Highly polluted, shrinking water body
Detailed Description	Fencing and plans for restoration in progress. Kaluves encroached. Highly polluted, with dumping of solid debris.
Size	2.09 ha
Deep water	None
Encroachment	Kaluves encroached
Connectivity	Stand alone lake
Flora (Visual Observation)	Marshy grass, weeds
Fauna (Visual Observation)	Birds and insects
Recommendation	Urgently requires comprehensive desilting and restoration program; and reclamation and restoration of kaluves, in order to provide a healthy supply of rainwater. This is a small lake and can easily be filled by precipitation if the kaluves are opened. Pollution should be treated by diversion, and treatment through biological control as the amounts of inflow are too small for an STP. As this lake is small in size, a small walking path can be provided surrounded by trees, which does not restrict the limited waterspread area. The walking path should not be circular, and should avoid the eastern swampy edge away from the road, leaving it as an undisturbed refuge for bird and insect life.

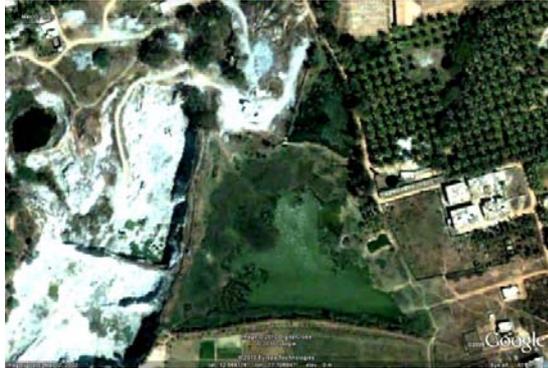
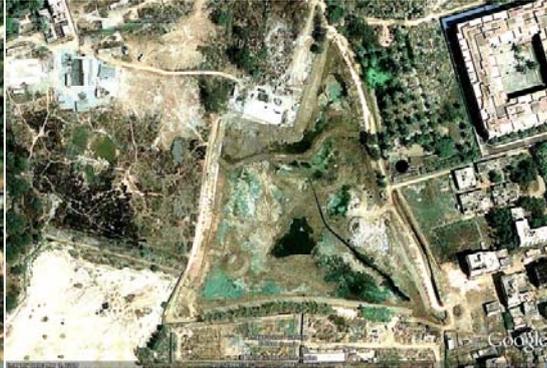
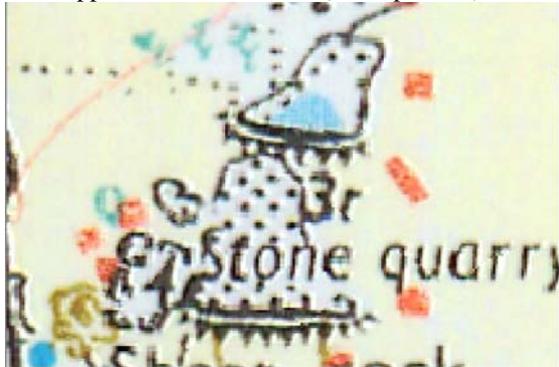
Lake/Tank Name	Chinnappanahalli kere
Status Of Water body	Polluted, drying water body
Detailed Description	A large part of the lake appears to have been filled and diverted for a park.
Size	2.63 ha
Deep water	0.43 ha
Encroachment	Lake appears encroached to north and northwest in comparison to Survey of India toposheet.
Connectivity	Inlet from surrounding landscape; outlet to Munnekollalu kere
Flora (Visual Observation)	Marshy grass, weeds
Fauna (Visual Observation)	Some birds and insects
Recommendation	This is a small lake and can easily be filled by precipitation, but only if all the kaluves are cleared from encroachments and opened. Pollution should be treated by diversion, and treatment through biological control as the amounts of inflow are too small for an STP. Some of the waterspread area appears to have been diverted for creation of a park at the northern end. There is significant space for the plantation of trees, and the additional land area should be used for creation of a tree park, instead of planting grasses and decorative shrubs, so that this area can serve as a lung space.

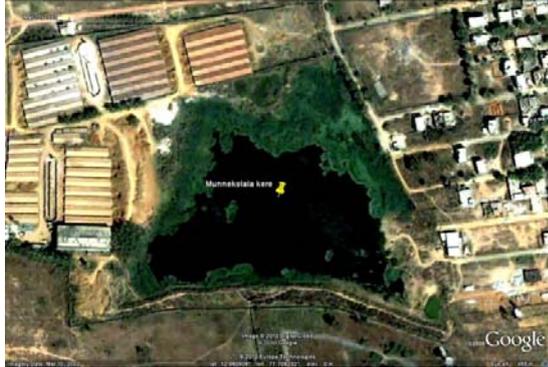
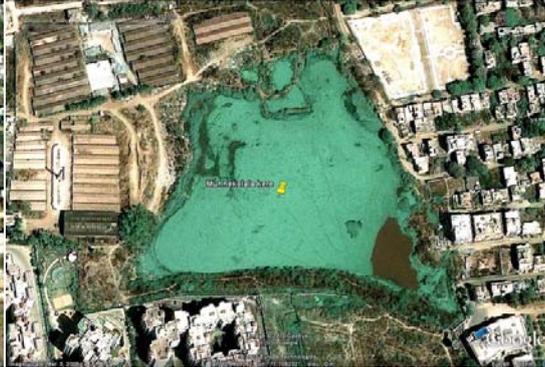
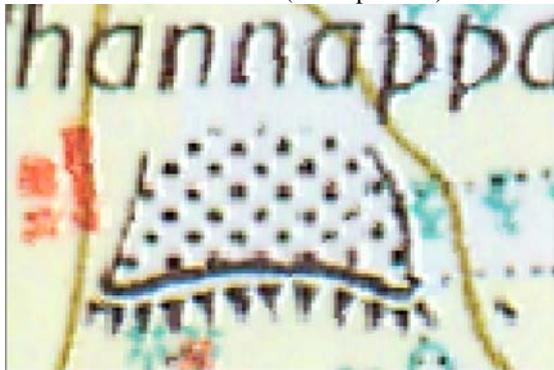
Lake/Tank Name	Munnekollalu kere
Status Of Water body	Polluted, shrinking water body
Detailed Description	Sewage observed flowing in to the lake; dumping of solid waste on the lake banks; lake bund is nonexistent in many areas; kaluves encroached; highly polluted, with overgrowth of weeds and water hyacinth
Size	4.1 ha
Deep water	None
Encroachment	Kaluves encroached
Connectivity	Inlet from Chinnappanahalli kere; outlet to Varthur kere
Flora (Visual Observation)	Banyan tree; water hyacinth; weeds
Fauna (Visual Observation)	Good bird and insect diversity
Recommendation	Urgently requires comprehensive desilting and restoration program; cleaning of solid waste; treatment and diversion of sewage; restoration of lake bund; and reclamation and restoration of kaluves, in order to provide a healthy supply of rainwater. This is a small lake and can easily be filled by precipitation if the kaluves are opened and the upstream Chinnappanahalli lake is restored. Pollution should be treated by diversion, and treatment through biological control as the amounts of inflow are too small for an STP. As this lake is small in size, a small walking path can be provided surrounded by trees, which does not restrict the limited waterspread area. There is scope for tree plantation along the north, west and east boundaries. The walking path should not be circular, and should avoid the northern swampy edge away from the road, leaving it as an undisturbed refuge for bird and insect life. There is a very old banyan tree with a small temple at the lake edge, and this should be protected as a sacred space and biodiversity refuge.
