## **Executive Summary**

## Lake networks in Mahadevpura constituency

## Current lake status in Mahadevpura

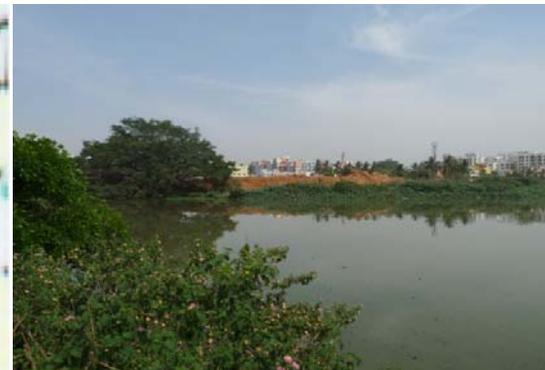
Munnekollalu kere – field visit

Lake/Tank Name	Munnekollalu kere
Status Of Water body	Polluted, shrinking water body
Detailed Description	Sewage observed flowing in to the lake; dumping of solid waste on the lake banks; lake bund is nonexistent in many areas; kaluves encroached; highly polluted, with overgrowth of weeds and water hyacinth
Size	4.1 ha
Deep water	None
Encroachment	Kaluves encroached
Connectivity	Inlet from Chinnappanahalli kere; outlet to Varthur kere
Flora (Visual Observation)	Banyan tree; water hyacinth; weeds
Fauna (Visual Observation)	Good bird and insect diversity
Recommendation	Urgently requires comprehensive desilting and restoration program; cleaning of solid waste; treatment and diversion of sewage; restoration of lake bund; and reclamation and restoration of kaluves, in order to provide a healthy supply of rainwater. This is a small lake and can easily be filled by precipitation if the kaluves are opened and the upstream Chinnappanahalli lake is restored. Pollution should be treated by diversion, and treatment through biological control as the amounts of inflow are too small for an STP. As this lake is small in size, a small walking path can be provided surrounded by trees, which does not restrict the limited waterspread area. There is scope for tree plantation along the north, west and east boundaries. The walking path should not be circular, and should avoid the northern swampy edge away from the road, leaving it as an undisturbed refuge for bird and insect life. There is a very old banyan tree with a small temple at the lake edge, and this should be protected as a sacred space and biodiversity refuge.

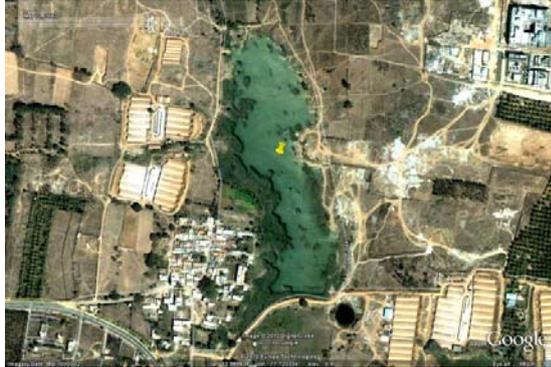
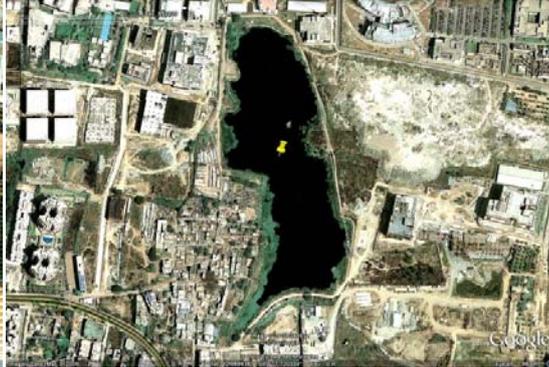
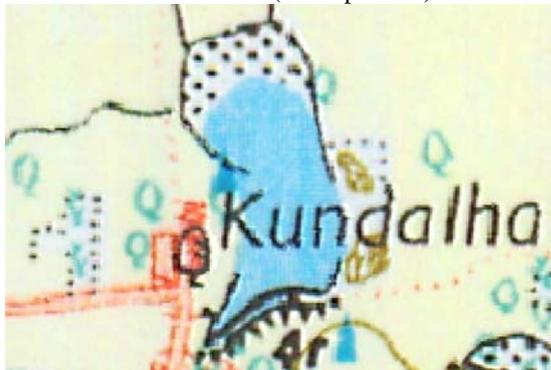
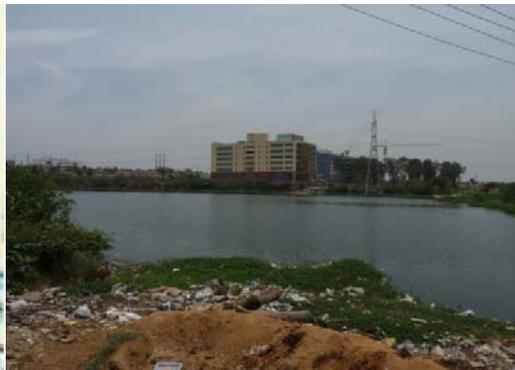
Lake/Tank Name	Kundalahalli kere
Status Of Water body	Reasonably healthy water body with some pollution
Detailed Description	Reasonably healthy water body, with some pollution due to sewage, and water hyacinth growth at the edges. There is a garbage dumping site next to the kaluve, as can be seen in the photograph, and this area is heavily used by cattle and stray dogs, with the garbage also blocking the kaluve.
Size	9.52 ha
Deep water	7.13 ha
Encroachment	Appears encroached on northwest edge compared to Survey of India toposheet; kaluves encroached
Connectivity	Inlet from surrounding landscape; outlet to Siddapura kere
Flora (Visual Observation)	Marshy grass, reeds
Fauna (Visual Observation)	Good diversity of bird and insect life; cattle and stray dogs and rodents at the garbage dump at one corner
Recommendation	This lake has good potential for storage of water, being largely a deep water lake. The village survey map should be checked to verify if encroachment has taken place at the northwest, as appears from the toposheet. The garbage area needs to be cleaned, and the lake should be fenced. The kaluves should be cleaned and cleared of encroachments. Sewage should be treated by biological control, and incoming sewage diverted to a downstream STP. There is significant potential for tree planting around the lake periphery. A narrow walking path can be maintained, but this should not be very wide as the lake itself is quite narrow, and cannot sustain further decrease in width. The walking path should not be circular and should avoid the northern boundary, where shallow water is present, leaving it as an undisturbed refuge for bird and insect life.

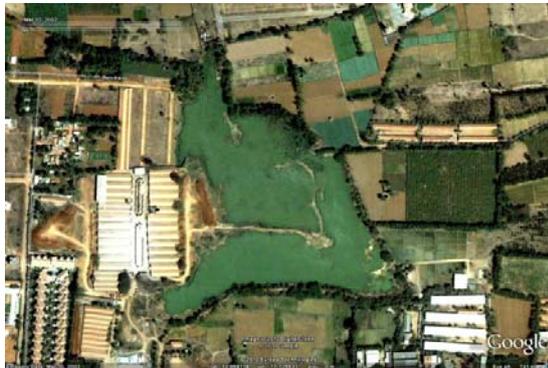
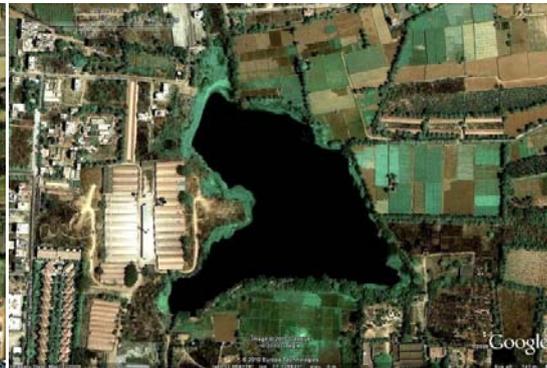
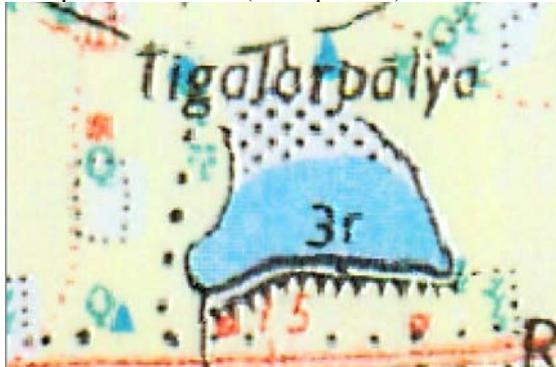
Lake/Tank Name	Siddapura kere
Status Of Water body	Reasonably healthy water body with some pollution
Detailed Description	Reasonably healthy, with some pollution leading to encroachment of water hyacinth.
Size	7.58 ha
Deep water	6.22 ha
Encroachment	Kaluves encroached
Connectivity	Inlet from Kundalahalli kere; outlet to Varthur kere
Flora (Visual Observation)	Marshy grass, water hyacinth, surrounded by trees and bamboo
Fauna (Visual Observation)	Good diversity of birds and insects
Recommendation	This lake has good potential for storage of water, as a large part of the lake is covered by deep water area. The kaluves should be cleaned and cleared of encroachments. Existing sewage should be treated by biological control, and incoming sewage diverted to a downstream STP. A walking path can be maintained, but should be narrow, so as to prevent reduction in the lake waterspread area. There is scope for further tree and bamboo plantation on the western boundary. The foreshore area should also be planted with trees to control siltation and soil erosion. The walking path should not be circular and should avoid the northern swampy area, leaving it as an undisturbed refuge for bird and insect life.

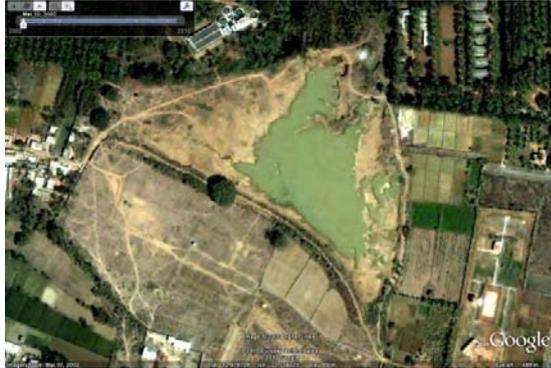
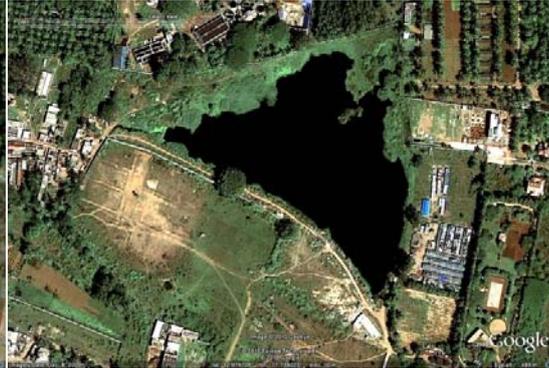
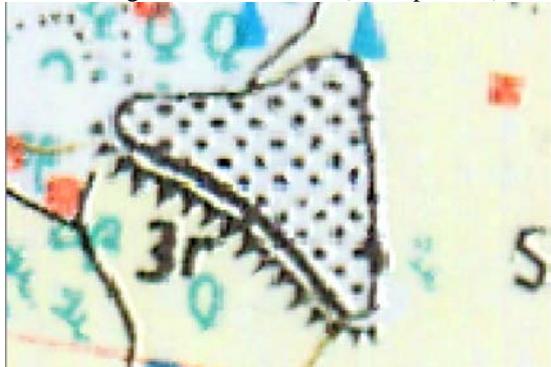
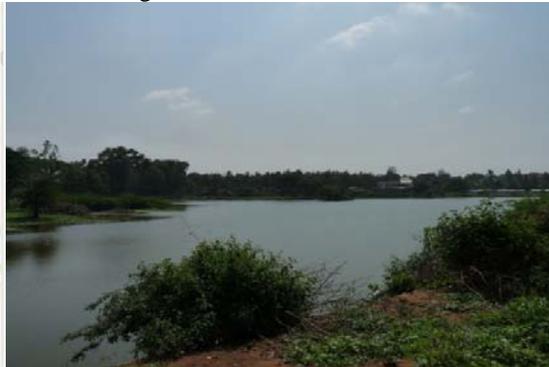
Lake/Tank Name	Pattandur Agrahara kere
Status Of Water body	Reasonably healthy water body
Detailed Description	Reasonably healthy status, with some pollution by sewage and encroachment of kaluves leading to shrinkage of waterbody and growth of water hyacinth.
Size	3.72 ha
Deep water	None
Encroachment	Kaluves encroached, lane appears encroached at the northwestern corner compared to Survey of India toposheet.
Connectivity	Inlet from surrounding landscape; outlet to Nallurahalli kere
Flora (Visual Observation)	Shrubs, marshy area, water hyacinth
Fauna (Visual Observation)	Good bird and insect diversity
Recommendation	Requires treatment of sewage through biological means, as well as diversion of sewage for treatment upstream after Srimantha kere, just before entry into Varthur kere, as the amounts of inflow in this lake are too small for an STP located here. Reclamation and restoration of kaluves is needed in order to provide a healthy supply of rainwater. This is a small lake and can easily be maintained in a healthy condition by precipitation if the kaluves are maintained free of blockage. There is scope for creation of a narrow walking path along with plantation of trees, being careful however not to restrict the limited waterspread area. The walking path should not be circular, and should avoid the northern swampy edge away from the road, leaving it as an undisturbed refuge for bird and insect life.

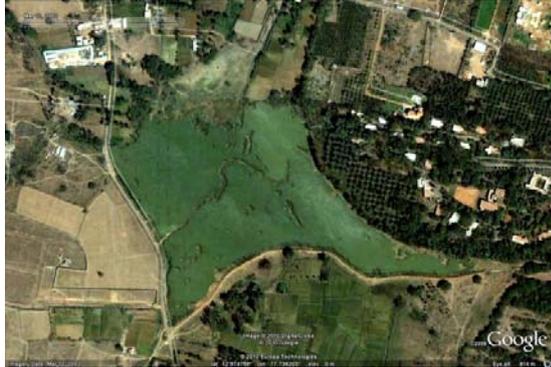
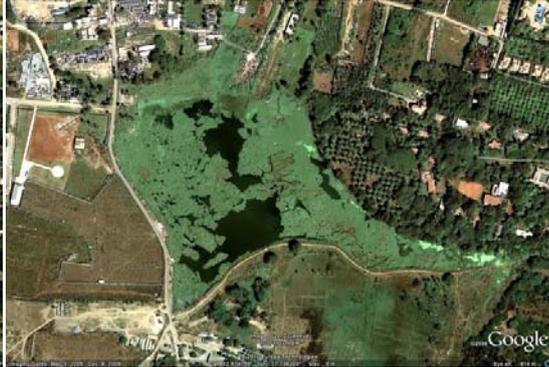
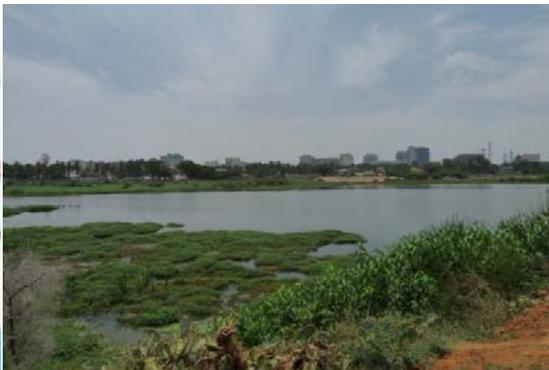
Lake/Tank Name	Nallurahalli kere
Status Of Water body	Polluted, shrinking water body
Detailed Description	Fencing completed. Kaluves encroached. Highly polluted, with dumping of solid waste and construction debris blocking some of the kaluves.
Size	11.61 ha
Deep water	None
Encroachment	Appears to be significantly encroached to the north based on comparisons with Survey of India toposheet. Kaluves encroached and blocked.
Connectivity	Inlet from Pattandur Agrahara kere; outlet to Srimantha kere
Flora (Visual Observation)	Marshy grass, reeds, thorny bushes, some trees
Fauna (Visual Observation)	Kingfishers, other birds and insects, rich biodiversity
Recommendation	Urgently requires comprehensive desilting and restoration program; cleaning of solid waste and removal of debris; reclamation, restoration and opening of kaluves, in order to provide a healthy supply of rainwater. <b>The village survey maps should be checked to confirm if there are encroachments to the north, and if so these should be reclaimed.</b> This lake can easily be filled by precipitation and by the water inflow from upstream Pattandur Agrahara kere, if the kaluves are opened – they are currently blocked by solid waste and construction encroachments. Pollution should be treated by treatment through biological control, and diversion followed by treatment in an STP upstream from Srimantha kere just before entering Vathur, as the amounts of inflow are too small for an STP. There is substantial scope for tree plantation. A walking path can be provided surrounded by trees, but the waterspread area should not be restricted further. The walking path should not be circular, and should leave the northern and eastern swampy areas as undisturbed refuge for biodiversity.

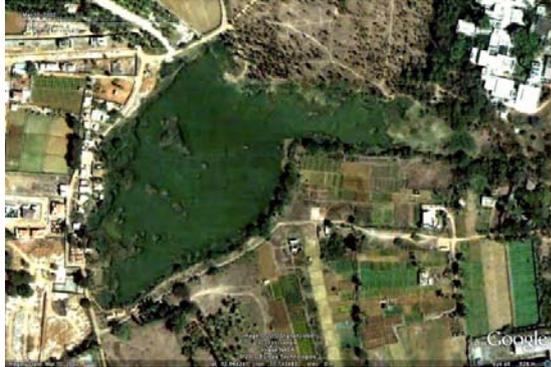
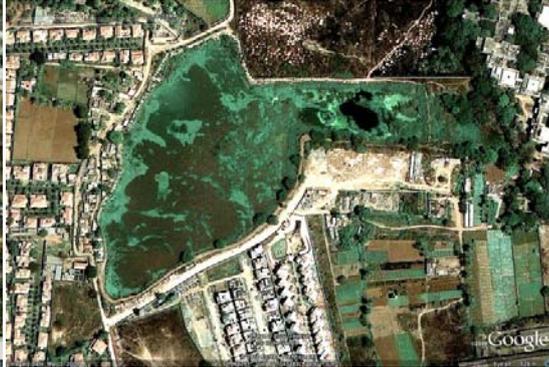
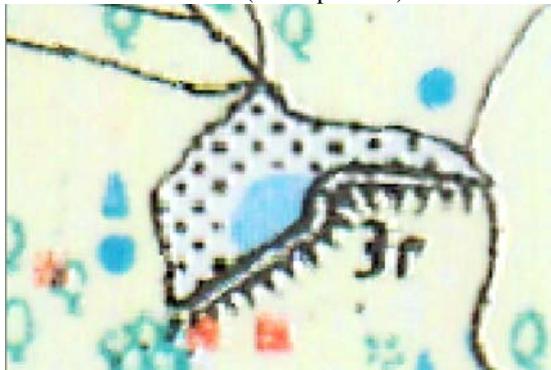
Lake/Tank Name	Srimantha kere/Sheelavanthara kere/R Narayanapura
Status Of Water body	Highly polluted water body, almost dry
Detailed Description	Kaluves encroached and blocked by dumping of solid debris.
Size	5.13 ha
Deep water	0.89 ha
Encroachment	Kaluves encroached; lake appears encroached on northeast and northwest boundaries compared to Survey of India toposheet.
Connectivity	Inlet from Nallurahalli kere; outlet to Varthur kere
Flora (Visual Observation)	Overgrown with marshy grass, thorny shrubs and weeds.
Fauna (Visual Observation)	Birds and insects
Recommendation	<b>The village survey maps should be checked to confirm if there is encroachment.</b> This lake urgently requires comprehensive desilting and restoration program; and reclamation and restoration of kaluves, in order to provide a healthy supply of rainwater. Care should be taken to maintain the original contours, with deep water areas in the south as per the toposheet. Pollution should be treated by diversion, and treatment through biological control in an STP just prior to inflow into Varthur lake. As this lake is small in size, a small walking path can be provided surrounded by trees, which does not restrict the limited waterspread area. There are very few trees, and there is substantial scope for plantation of appropriate shade providing and biodiversity friendly trees and plants around the boundary. The walking path should not be circular, and should avoid the northern boundary, leaving it as an undisturbed refuge for bird and insect life.

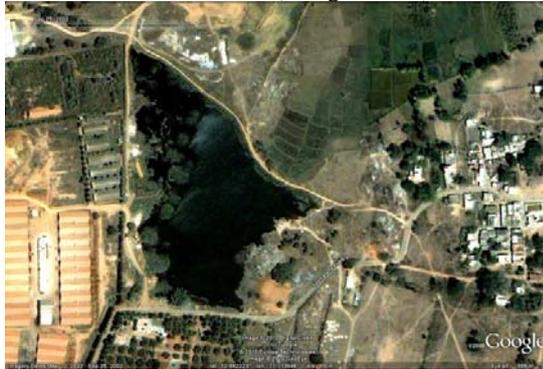
Sonnenahalli kere – 2002 (Google Earth)

Lake/Tank Name	Sonnenahalli kere/Sitaram Palya
Status Of Water body	Highly polluted, shrinking water body
Detailed Description	Kaluves encroached. Highly polluted, drying lake.
Size	4.53 ha
Deep water	None
Encroachment	Kaluves encroached
Connectivity	Inlet from surrounding landscape; outlet to Hoodi kere 2
Recommendation	Urgently requires comprehensive desilting and restoration program; and reclamation and restoration of kaluves, in order to provide a healthy supply of rainwater. This is a small lake and can easily be filled by precipitation if the kaluves are opened. Pollution should be treated by diversion, and treatment through biological control, as the amounts of inflow are too small for an STP here. There is substantial scope for the plantation of appropriate shade giving and biodiversity friendly trees around the lake, particularly in the foreshore area. As this lake is small in size, a small walking path can be provided surrounded by trees, which does not restrict the limited waterspread area. The walking path should not be circular, and should avoid the southern swampy edge, leaving it as an undisturbed refuge for bird and insect life.

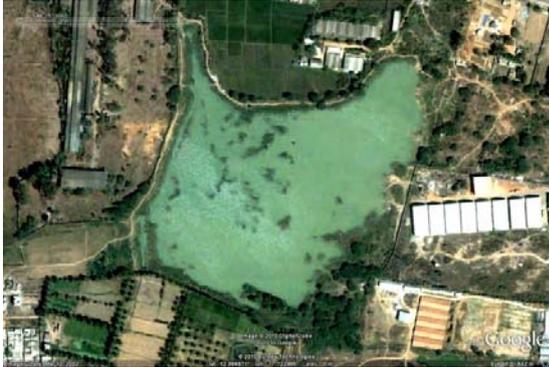
Hoodi kere 2 – 2009 (Google Earth)

Lake/Tank Name	Hoodi kere 2
Status Of Water body	Healthy water body
Detailed Description	Water body in reasonably good condition, with some pollution
Size	11.31 ha
Deep water	None
Encroachment	Kaluves encroached
Connectivity	Inlet from Sonnenahalli kere; outlet to Sadaramangal kere
Flora (Visual Observation)	Marshy grass and trees at periphery
Fauna (Visual Observation)	Good bird and insect diversity
Recommendation	In reasonably good condition, but requires to be maintained by clearing upstream and downstream kaluves, and diversion of sewage for treatment upstream after Sadaramangal kere. There are quite a few trees at the periphery, but this should be supplemented by planting additional trees especially at the western and southern boundary, along the walking path.

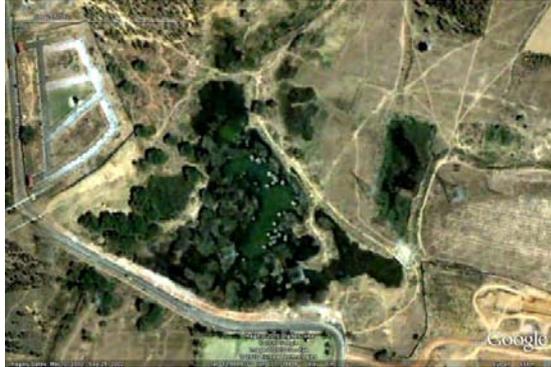
Hoodi kere 1– 2009 (Google Earth)

Lake/Tank Name	Hoodi kere 1
Status Of Water body	Highly polluted, shrinking water body, almost dry
Detailed Description	Lake is fenced. Kaluves are encroached. Highly polluted, and almost dry.
Size	6.28 ha
Deep water	None
Encroachment	Kaluves encroached
Connectivity	Inlet from surrounding landscape; outlet to Sadaramangal kere
Flora (Visual Observation)	Marshy grass, weeds
Fauna (Visual Observation)	Some bird and insect diversity, snakes, mongoose and small rodents.
Recommendation	Urgently requires comprehensive desilting and restoration program; and reclamation and restoration of kaluves, in order to provide a healthy supply of rainwater. This is a small lake and can easily be filled by precipitation if the kaluves are opened. Pollution should be treated by diversion, and treatment through biological control as the amounts of inflow are too small for an STP. As this lake is small in size, a small walking path can be provided surrounded by trees, which does not restrict the limited waterspread area. The walking path should not be circular, and should avoid the eastern swampy edge, leaving it as an undisturbed refuge for biodiversity.

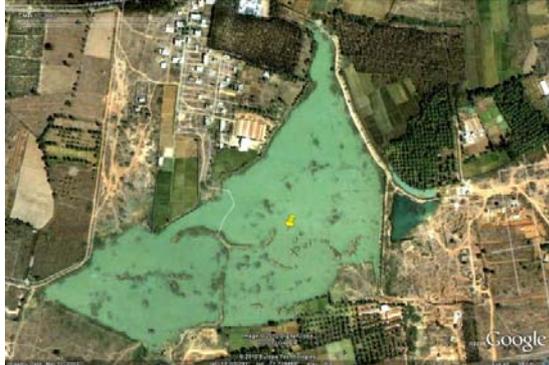
Sadaramangal kere – 2009 (Google Earth)

Lake/Tank Name	Sadaramangal kere
Status Of Water body	Reasonably healthy water body with some pollution.
Detailed Description	Plans for restoration in progress. Kaluves encroached. Polluted by entry of sewage.
Size	21.37 ha
Deep water	None
Encroachment	Kaluves encroached
Connectivity	Inlet from Hoodi kere 1 and Hoodi kere 2; outlet to Yellamallappa Chetty kere
Flora (Visual Observation)	Marshy grass, weeds, trees
Fauna (Visual Observation)	Good bird and insect diversity
Recommendation	Requires reclamation and restoration of kaluves, bund treatment, some dredging near the banks, and treatment of sewage by diversion (followed by treatment at an STP near Yellamallappa Chetty kere) , and treatment through biological control. A small walking path can be provided surrounded by trees, which does not restrict the limited waterspread area. There is substantial scope for tree plantation around the lake, and in the foreshore area to control siltation and soil erosion. The walking path should not be circular, and should avoid the western swampy edge, leaving it as an undisturbed refuge for bird and insect life.

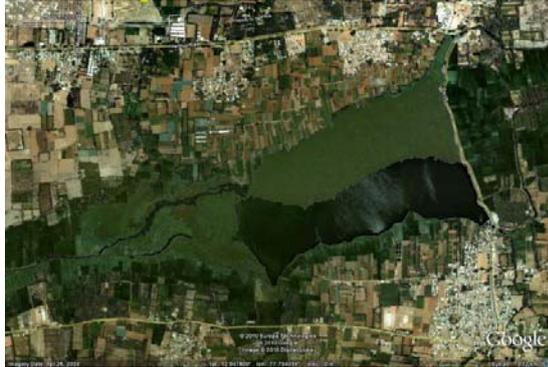
Varthur kere – 2009 (Google Earth)

Lake/Tank Name	Varthur kere
Status Of Water body	Highly polluted, encroached water body
Detailed Description	Highly polluted with sewage, industrial effluents and medical waste flowing in from multiple lakes. Kaluves including the Bellandur canal are badly encroached.
Size	166.87 ha
Deep water	152.08 ha
Encroachment	Lake and kaluves encroached
Connectivity	Inlet from multiple lakes
Flora (Visual Observation)	Marshy grass, weeds
Fauna (Visual Observation)	Good birds and insect diversity
Recommendation	This is one of Bangalore’s largest lakes – maintaining the entire waterspread area is critical for the ground water table in this area. The lake urgently requires prevention of further pollution by diverting sewage, industrial waste and hospital waste; biological treatment; <b>creation of multiple STPS</b> as the current STP is under capacity; dredging and restoration of the lake; bund restoration, and <b>removal of encroachments</b> from lake and kaluves in order to provide a healthy supply of rainwater. The restoration should be done keeping in mind this lake’s original status as a <b>deep water lake</b> . Trees should be planted around the periphery, and in the foreshore area to control soil erosion and check pollution. Bicycle and walking trails should be created around the lake.
